Assessing the Condition and Damage of a Stilt Wooden Home in an Area Prone to Floods

Nur Qamariah Hasmeddy, Ara Billa Biton, Avyda Tang Pei Chin, Sirhajwan Idek*, Jovinia Danil, Dayang Amidah Amin, Dayang Siti Khatijah

Research and Innovation Department, Keningau Vocational College, Keningau, Sabah, Malaysia

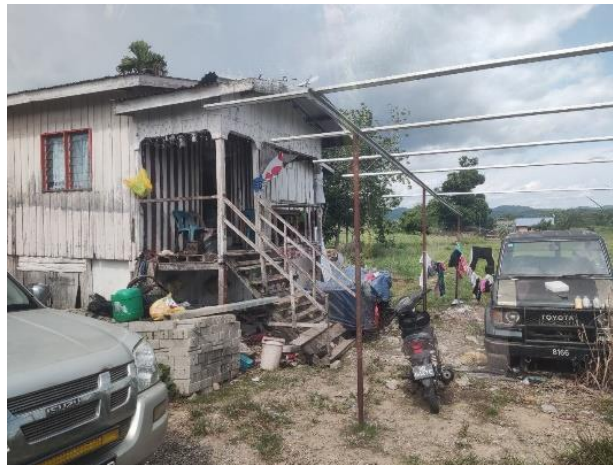
Figure 1. The Exterior Shot of the House

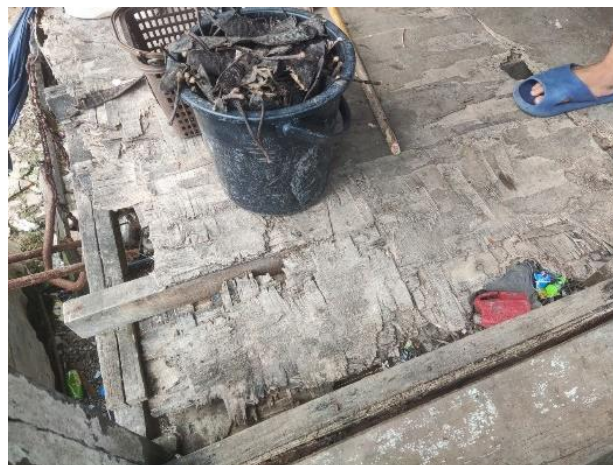
This study focused on a stilt wooden home in which its interiors and exteriors have decayed and degraded severely that it probably posed dangers to the occupants. The structures of certain parts of the house such as the porch roofs, the staircase to its porch, the porch railings and the kitchen floors have deteriorated to the extent that they have become too weak, flimsy and broken with some pieces were already gone. Hence, this required immediate attention.

Figure 2. The Floor of the Porch

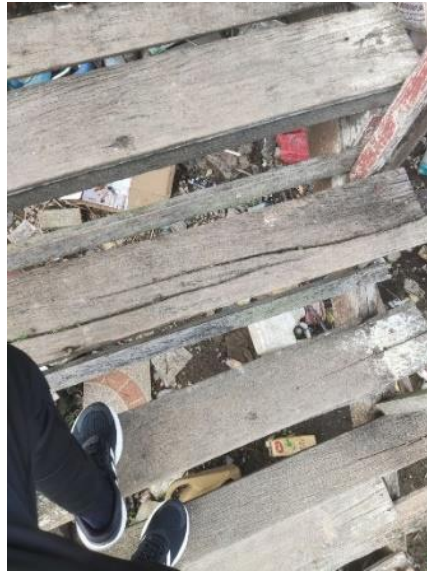
Figure 3. The Staircase

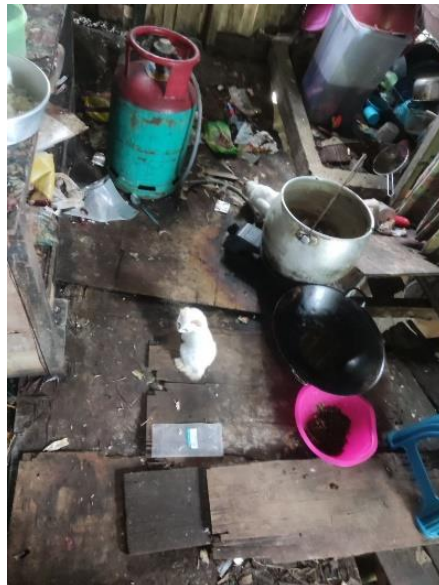
Figure 4. The Floor of the Kitchen

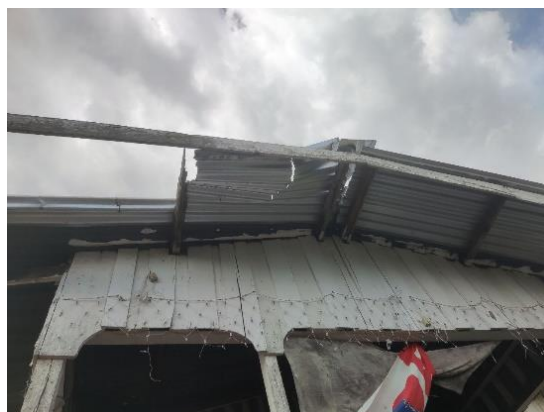
Figure 5. The Zinc Roof of the Front Part of the House

Given the condition of the home, the repair and restoration work should focus on the parts that can pose immediate danger to the occupants such as the floors, the staircase and the railings as well as the likely root of cause for the rapid deterioration of the house which was the decrepit zinc roofing which exposed the furniture and the interior of the house to rainwater which rendered the wood moist which further weakened it and susceptible to termite infestation. Another feasible solution is to create a raft foundation which is frequently used in places without strong soil and this can help the house remain stable while mitigating the effects of floodwater or moist soil as a result of persistent puddles.
