# INTERNATIONAL JOURNAL OF MULTIDISCIPLINARY: APPLIED BUSINESS AND EDUCATION RESEARCH

### Radiography of Clavicula Os with Suspected Avulsion Fracture in Advent Medan General Hospital

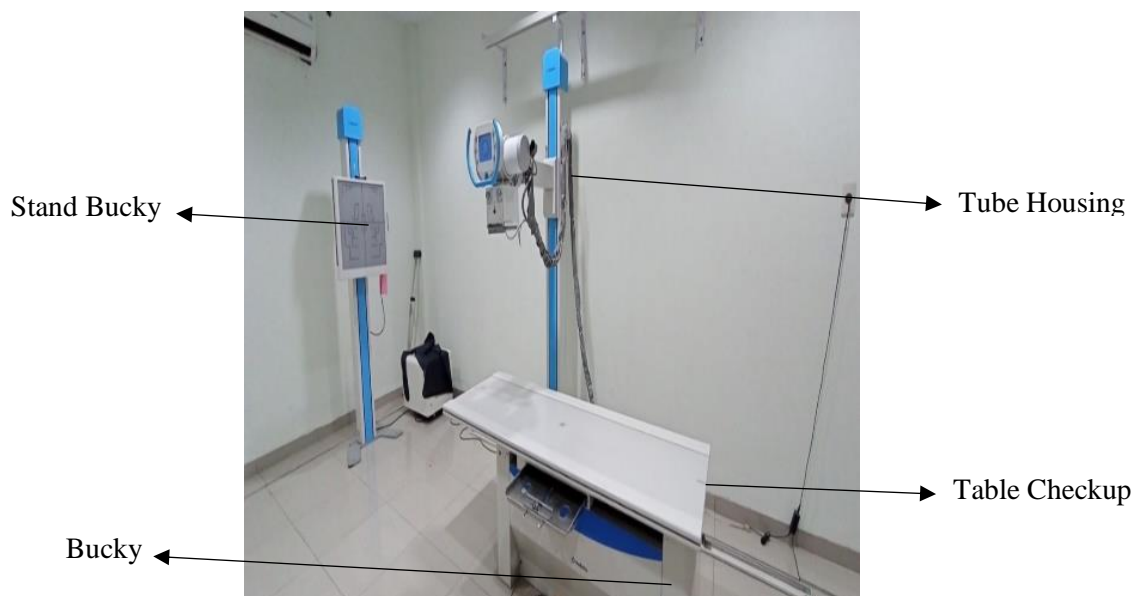
Figure 1. Medonica X-ray plane at Medan Adventist General Hospital

Brand Airplane: MEDONICA  
Aircraft Type : BLD-02A (Collimator)  
Date : 2018.11  
Input Power : AC24V, 7A

Weight : 6 kg  
Max Voltage : 125 kV  
Service aircraft : radiography

Before it's done action radiography, aircraft x-ray more formerly turned on and conducted warming up in accordance with procedure on aircraft X-ray so that all component aircraft x-ray could work by maximum. Aircraft X - rays used on inspection radiography os clavicle with guess fracture alvulsion is aircraft that have capacity tall, have bucky.

In inspection os clavicle use aircraft x-ray i.e. general X-ray unit at Home Sick General Adventist Medan with data as following :

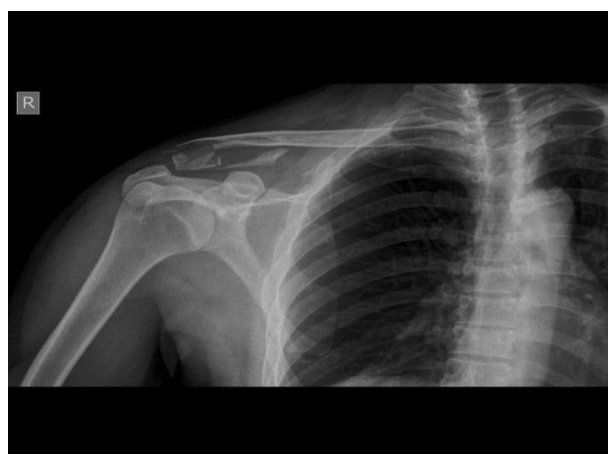
Figure 3. Antero-posterior projection of the os clavicle

Image criteria:

Look fracture of the tip of the clavicle right  
The other bones around the right shoulder joint are visible normal.

Position Patient : The patient is in an erect position and the cassette is vertical at the end of the shoulder joint to be photographed. And shooting does not use grid

Position Object : Position the shoulder and clavicle in the middle of the cassette, then

the arms and hands are placed beside the body in a position relax.

FFD : 90 cm  
Central \_ Point (CP) : Mid Os Clavicle  
Central Ray (CR) : Horizontal if the patient erect  
Cassette : 24 x 30 cm  
Factor Exposure : 72 kV , 16 mAs

Which was read by dr.Yudha Sp,OT with a description of the results of the examination: It appears that the fracture of the distal clavicle avulsion, humeral head and scapula are normal.

Conclusion: Fracture of the distal clavicle avulsion.
